# Shobers Run Habitat Improvement and Sediment Reduction

2021 to 2023

Phase One (2021) – Construction of two modified mud-sills and two log-framed stone deflectors

Phase Two (2023) – Filling and regrading stream bank above and behind larger Phase One mud-sill

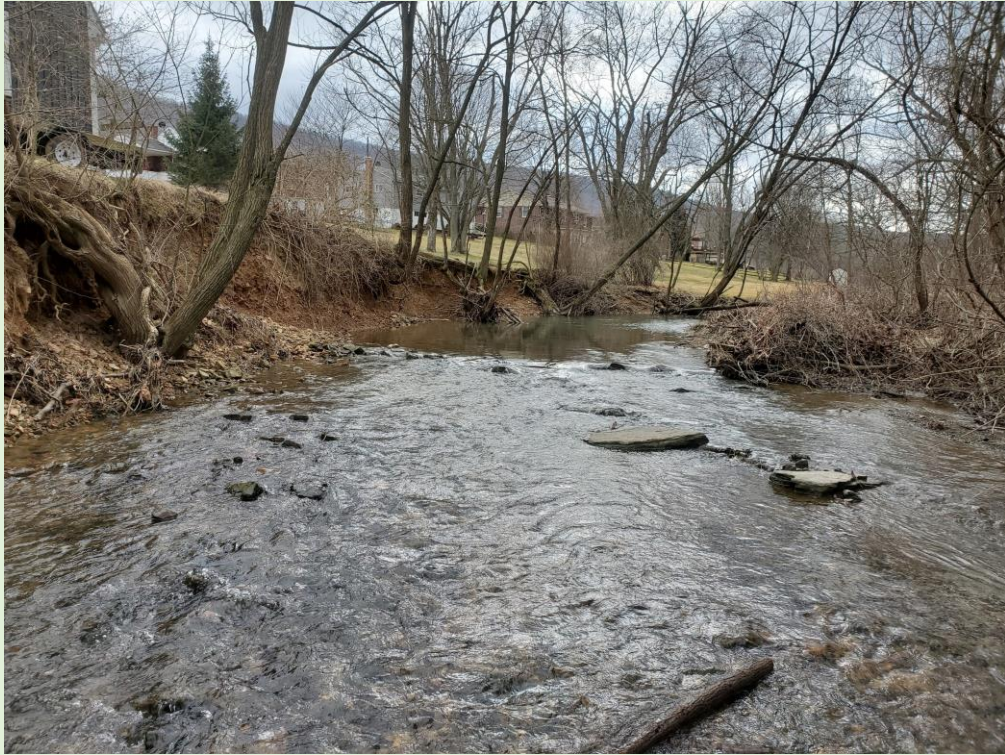
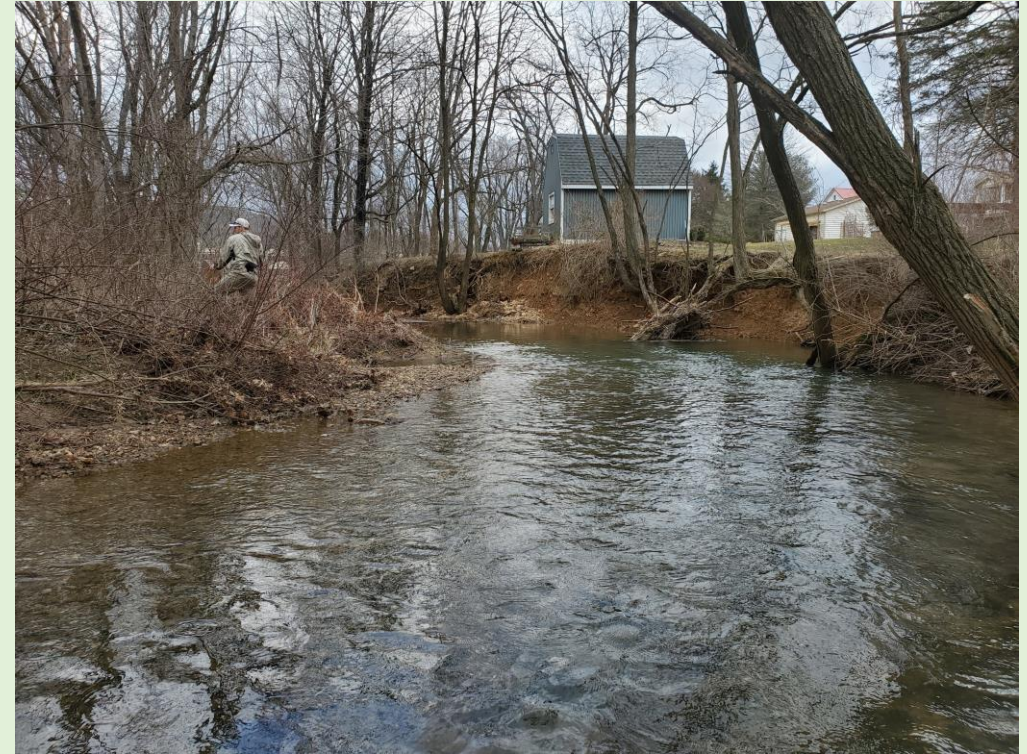
These photos were taken on February 4, 2020

These two images illustrate the main area of focus for Phase One from upstream (right) and downstream (below). The landowner of the property with the blue shed was the first to contact the CD and FBTU. This site has the largest area of eroding vertical stream bank in the entire project area.

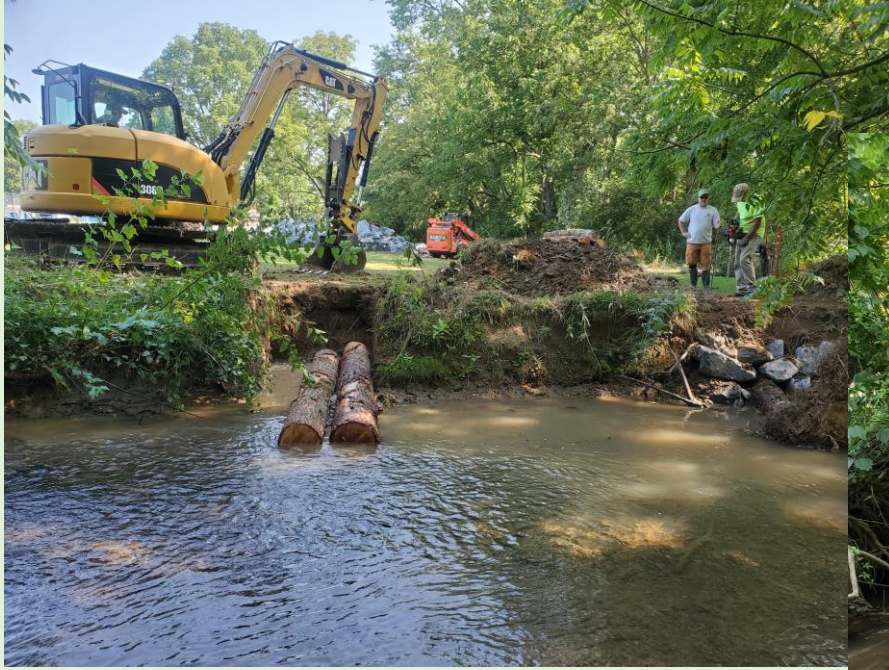
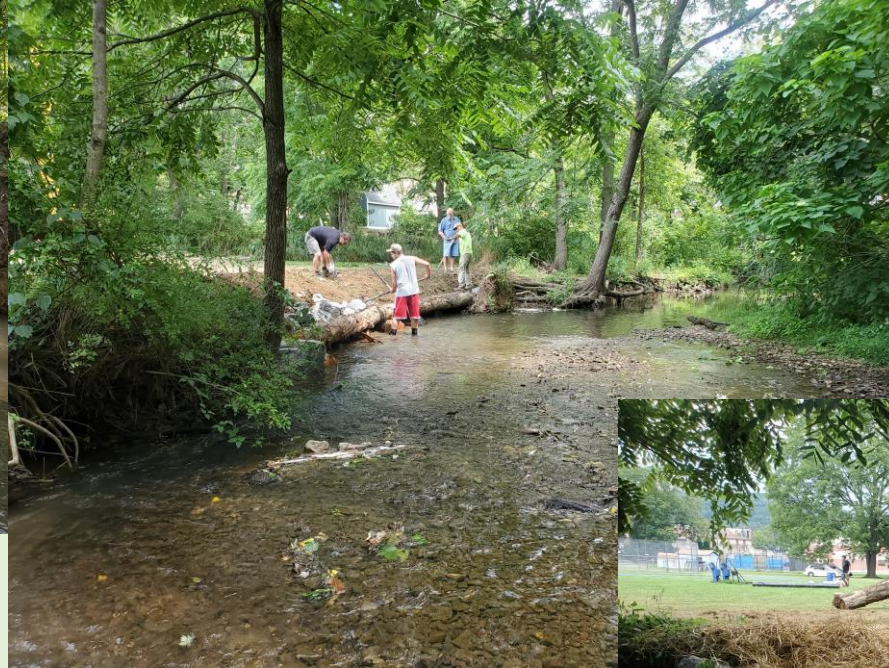
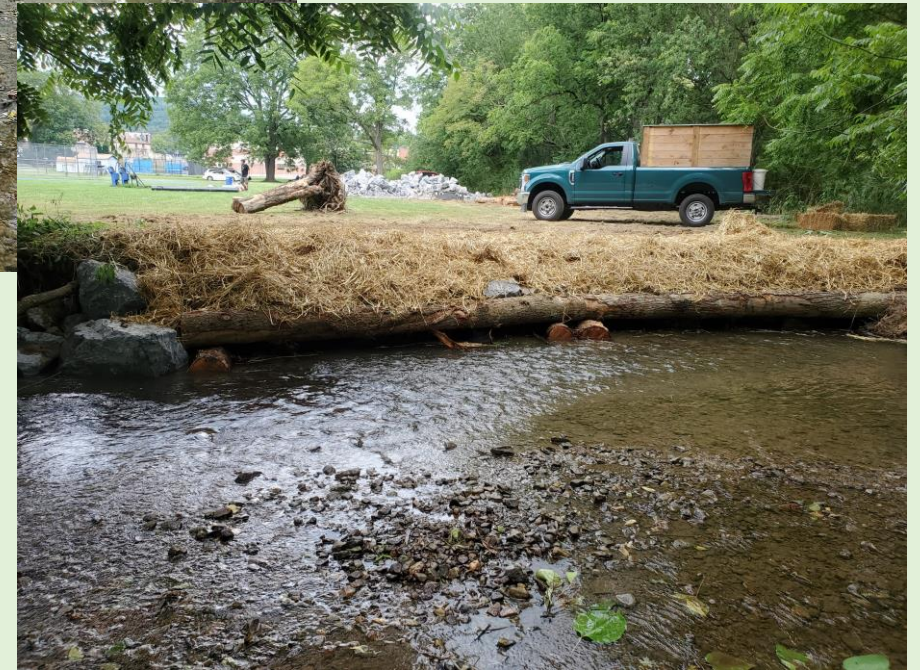
August 5, 2021 – Upstream and ‘around-the-corner” from the large mud-sill location, a small mud-sill and root wad were placed on an undercut eroding bank.

Note: This work corresponds to the device to the left of the “B” on the plan view aerial photo of the project area.

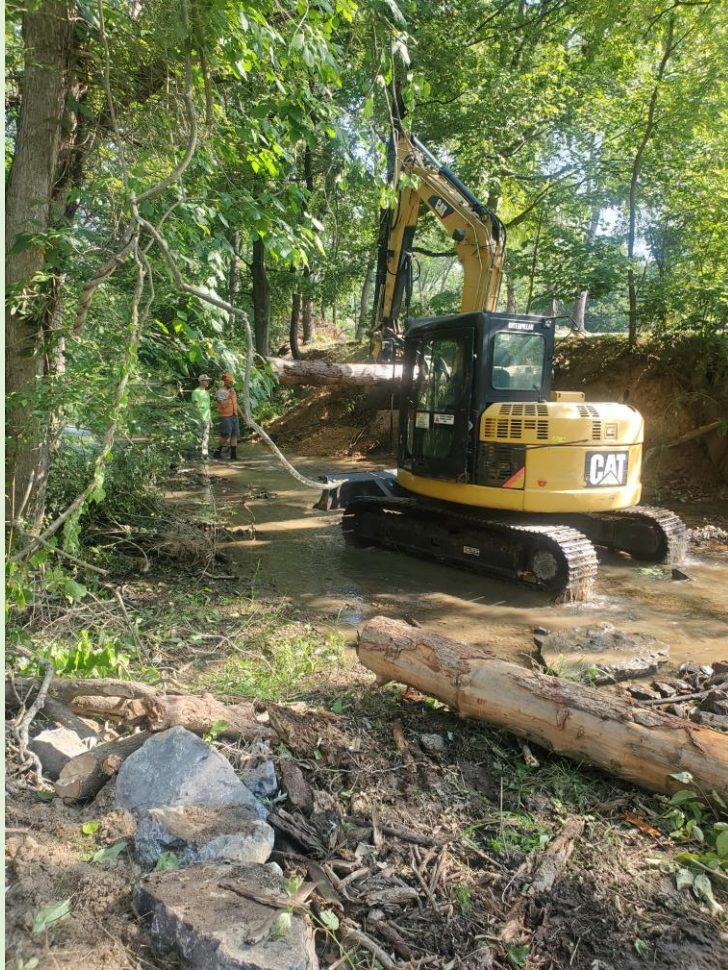
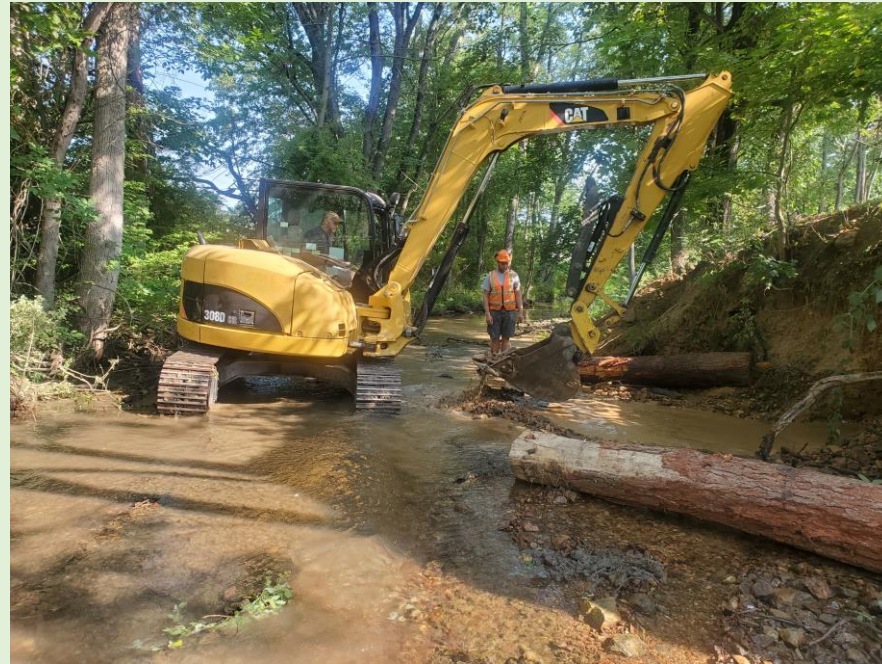
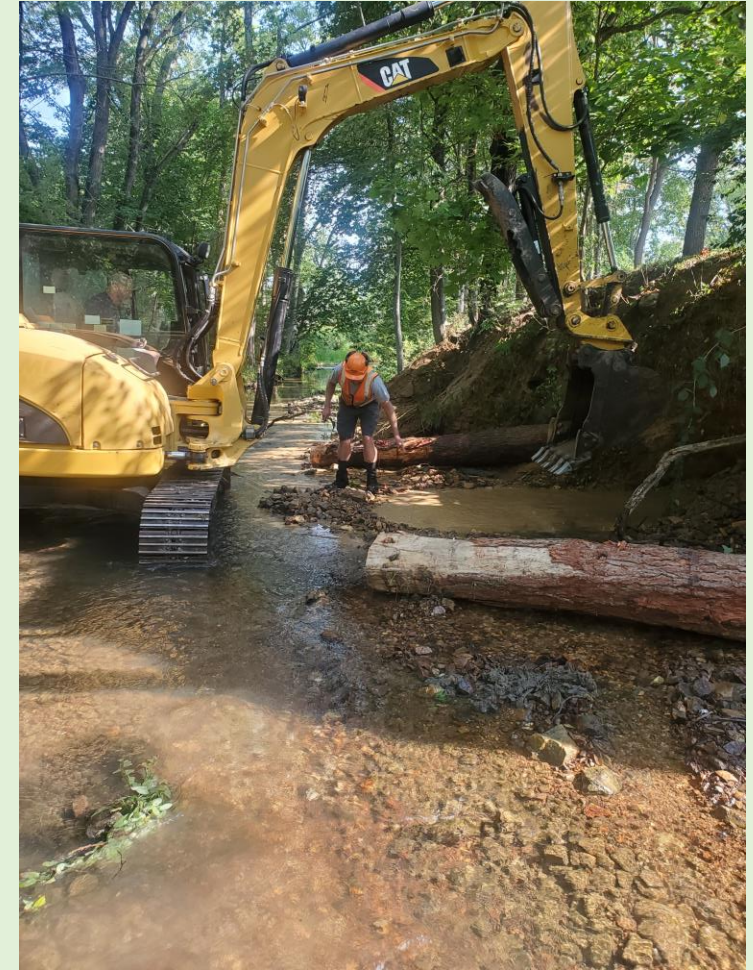
August 6, 2021 – Cutting first trenches and placing sill logs.

Note: This work corresponds to the device to the left of the “A” on the plan view aerial photo of the project area.

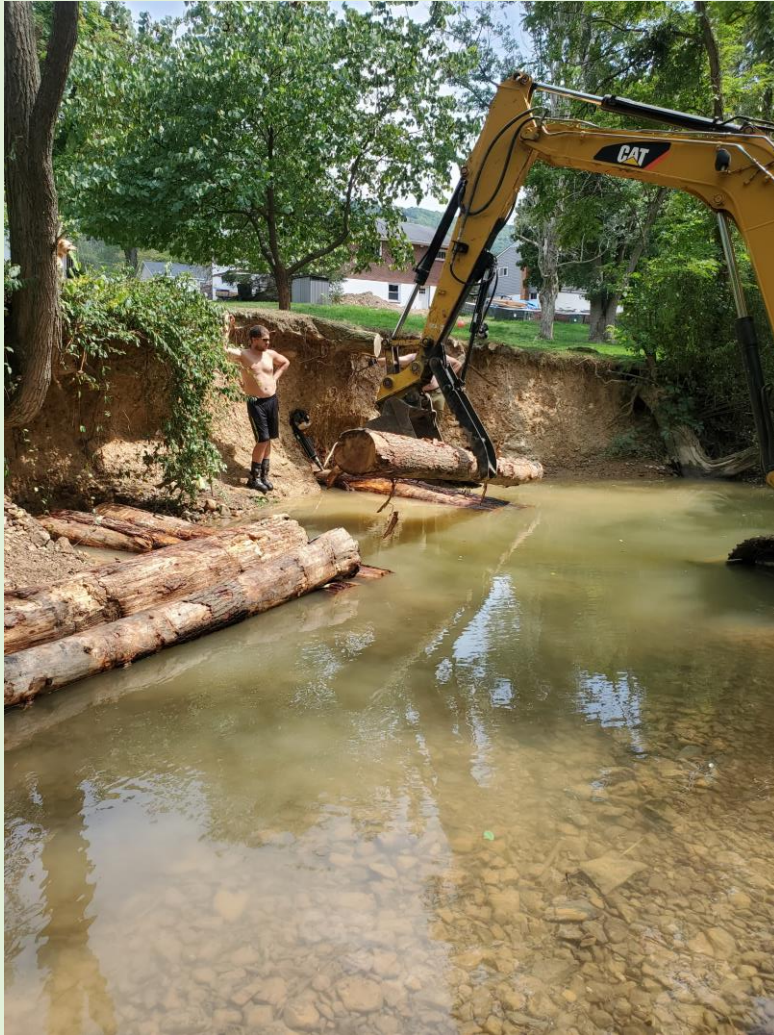
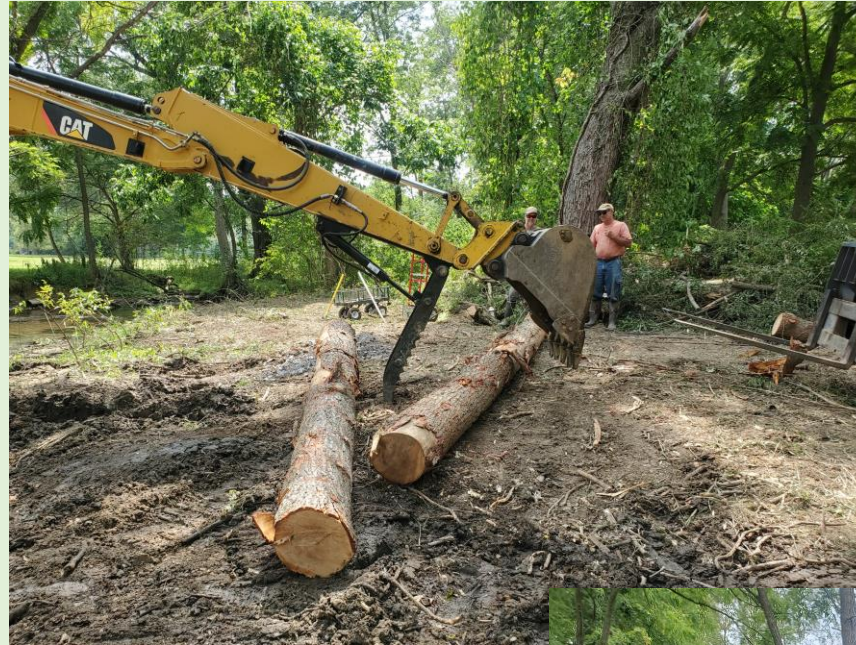
August 6, 2021 – Placing and pinning face logs.

Note: This work corresponds to the device to the left of the “A” on the plan view aerial photo of the project area.

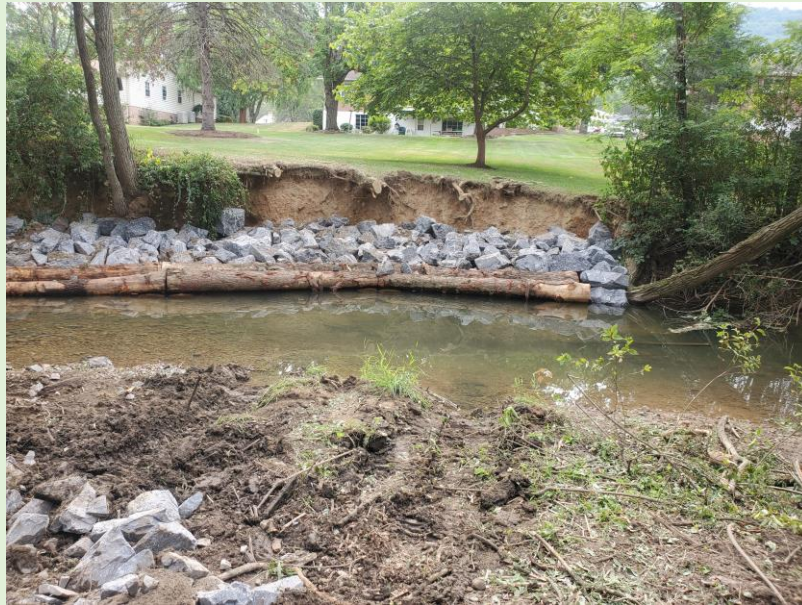
August 7 – Large rock appears on mud-sill.

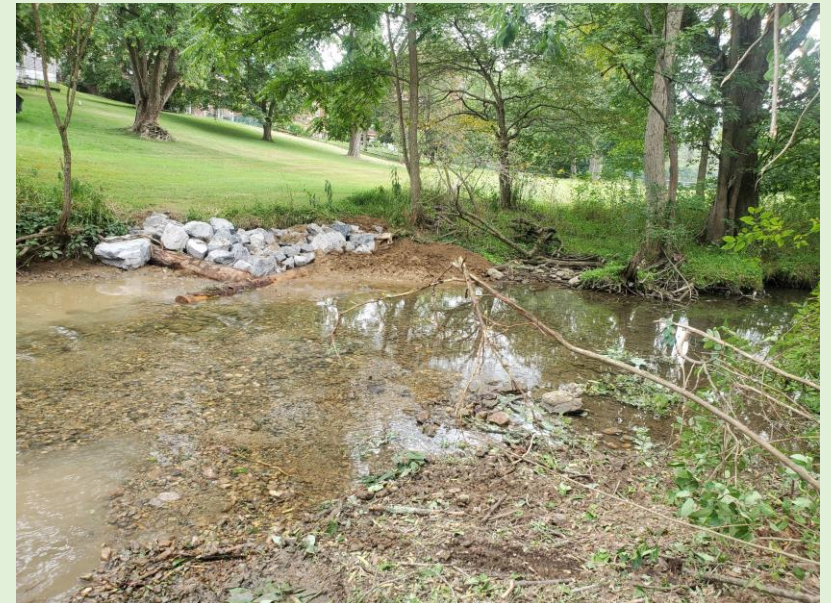
August 7 – Log-framed rock deflector adjacent to large mud-sill.

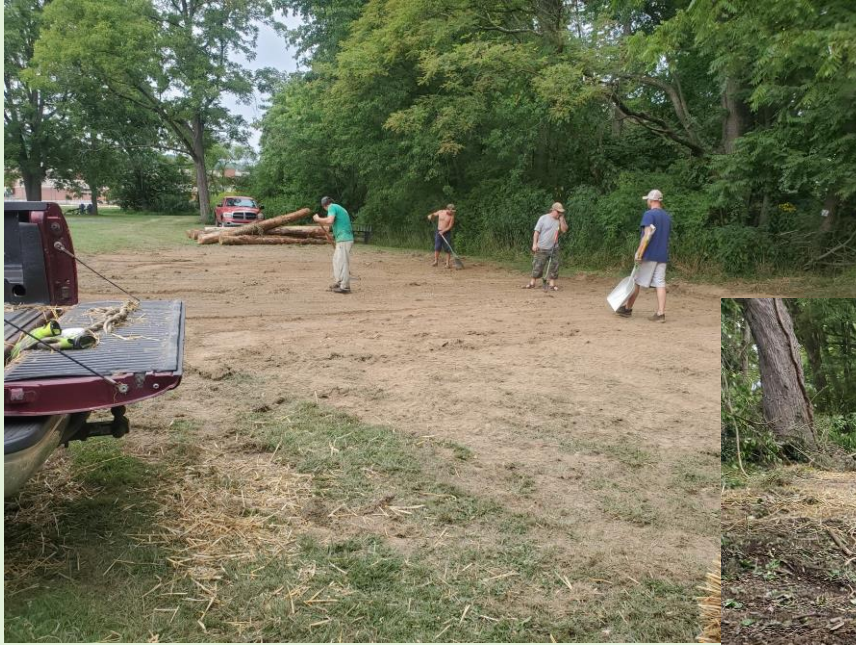
August 7, 2021 – Smoothing tire ruts and picking rocks.

August 7, 2021 – Seeding and mulching.

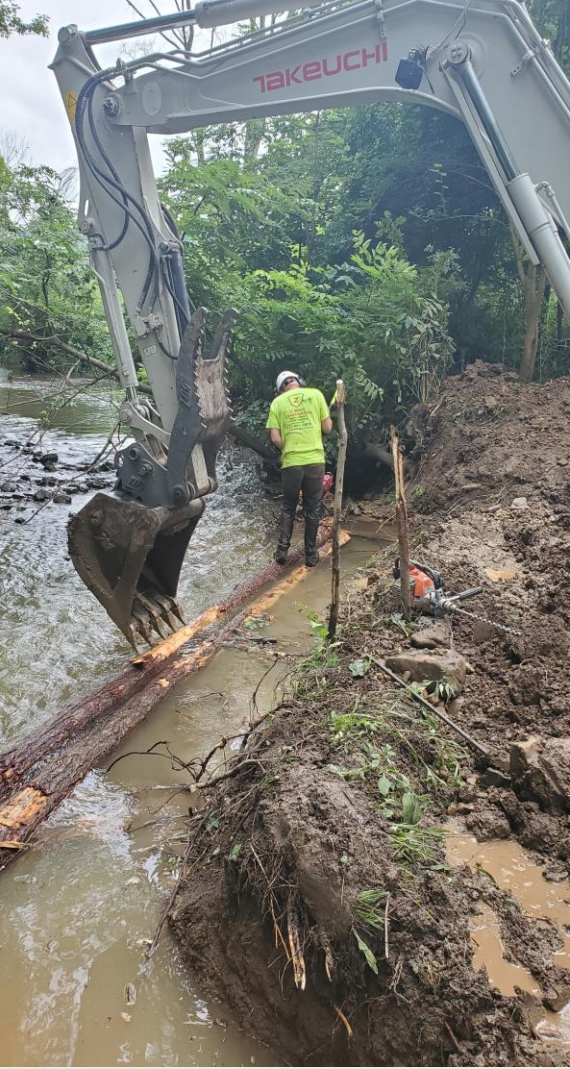
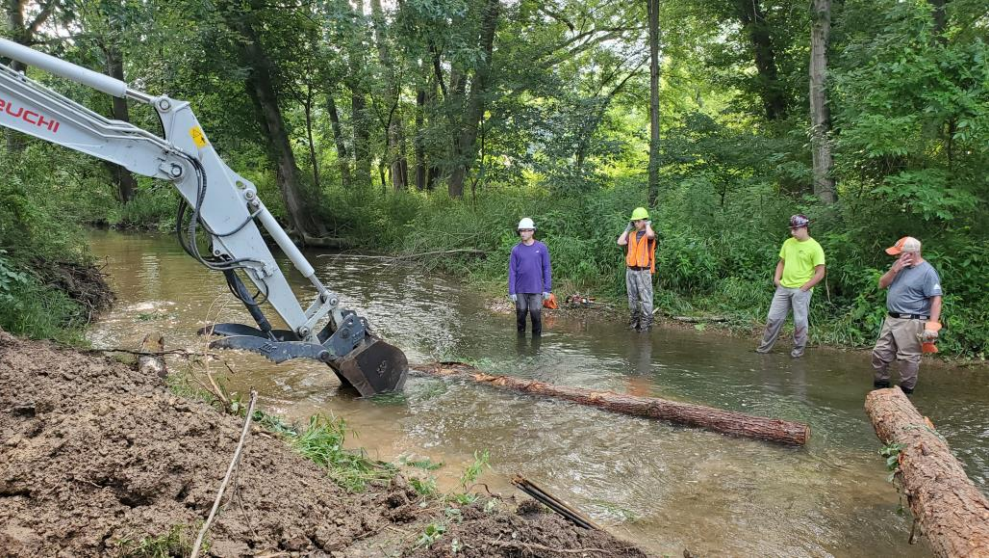
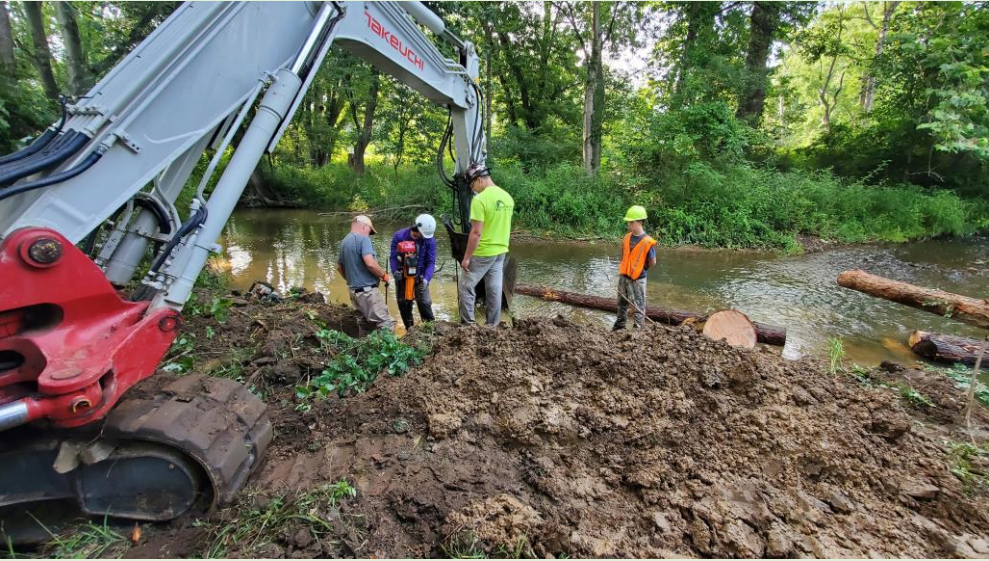
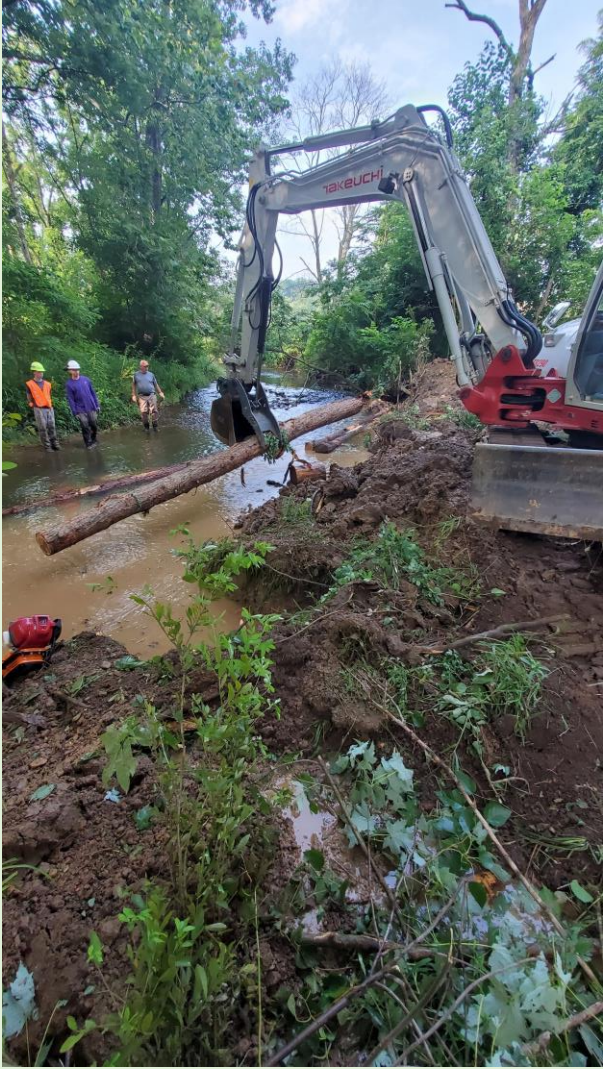
Phase Three – July 19 – 21, 2023

Note: This work corresponds to the device to the left of the “D” on the plan view aerial photo of the project area.

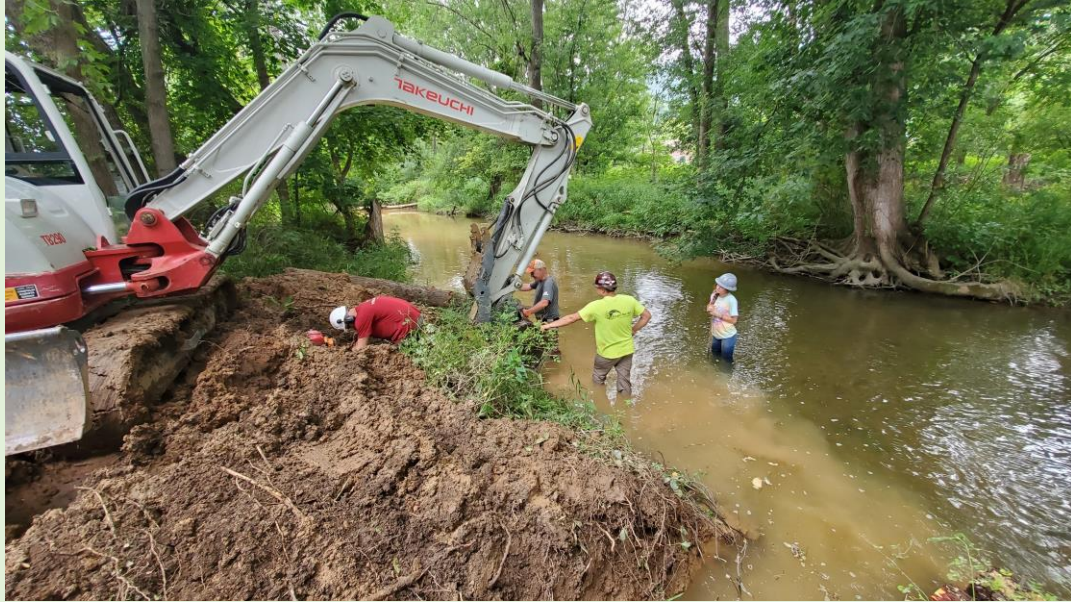
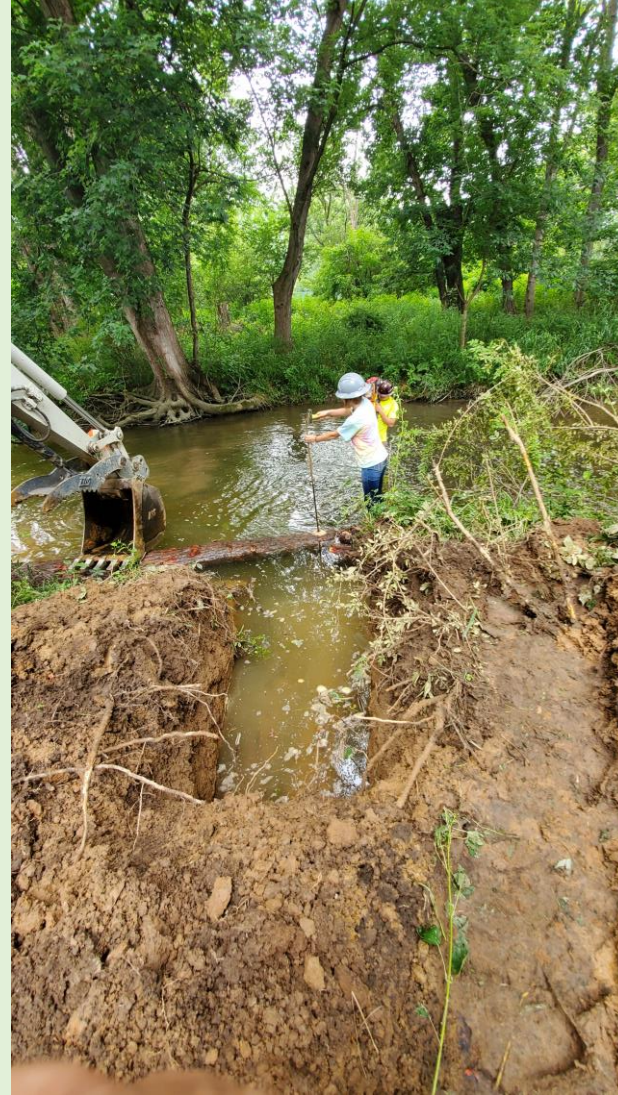
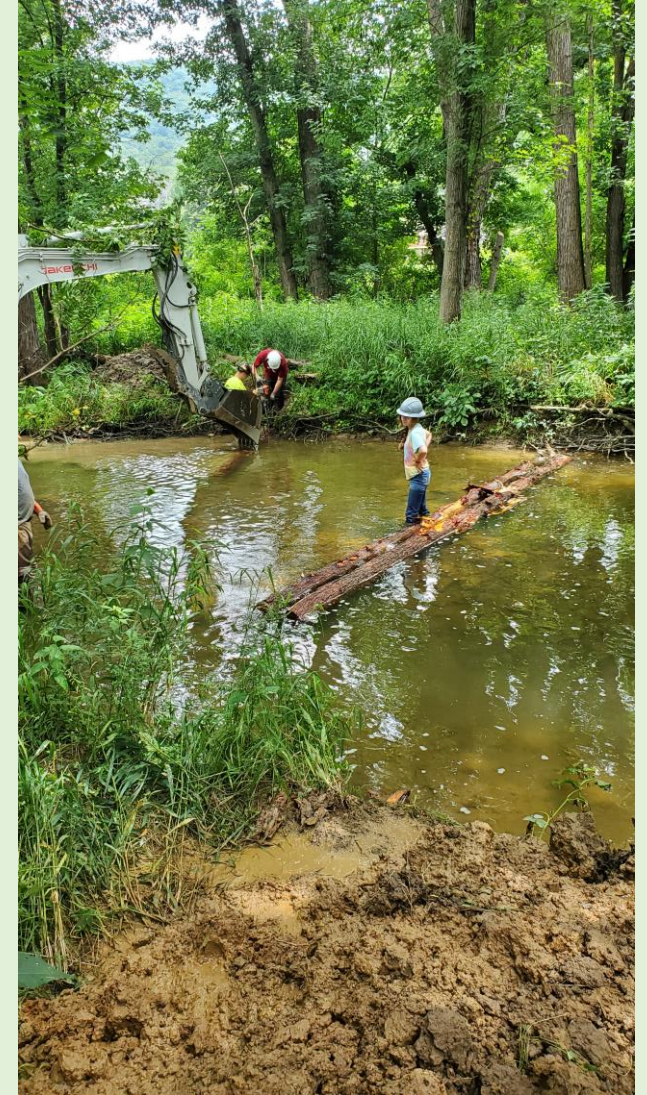
## Phase Three – July 20, 2023

Note: This work corresponds to devices between “C” and “D” on the plan view aerial photo of the project area.

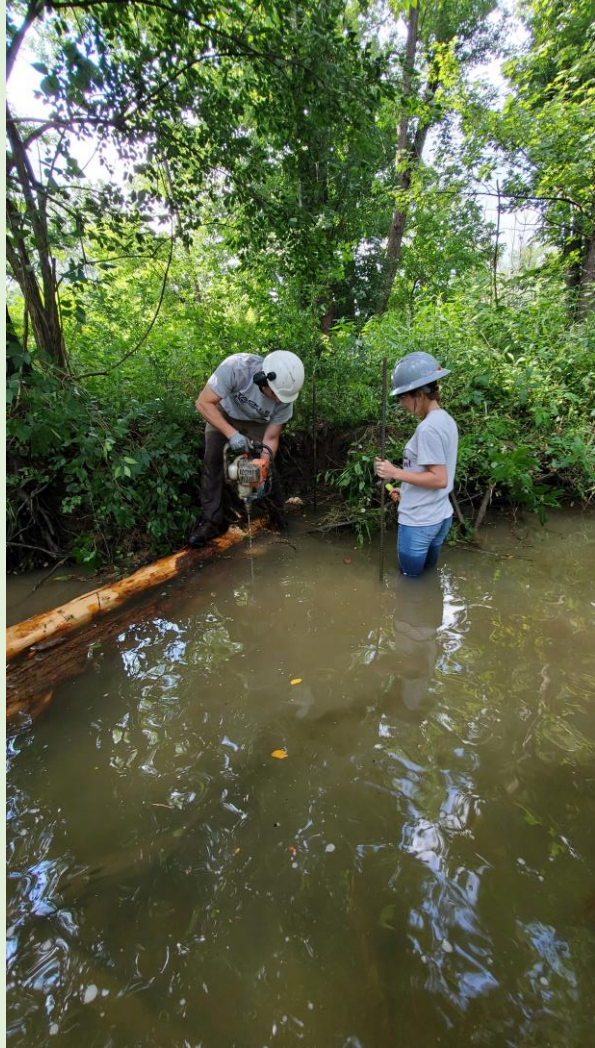
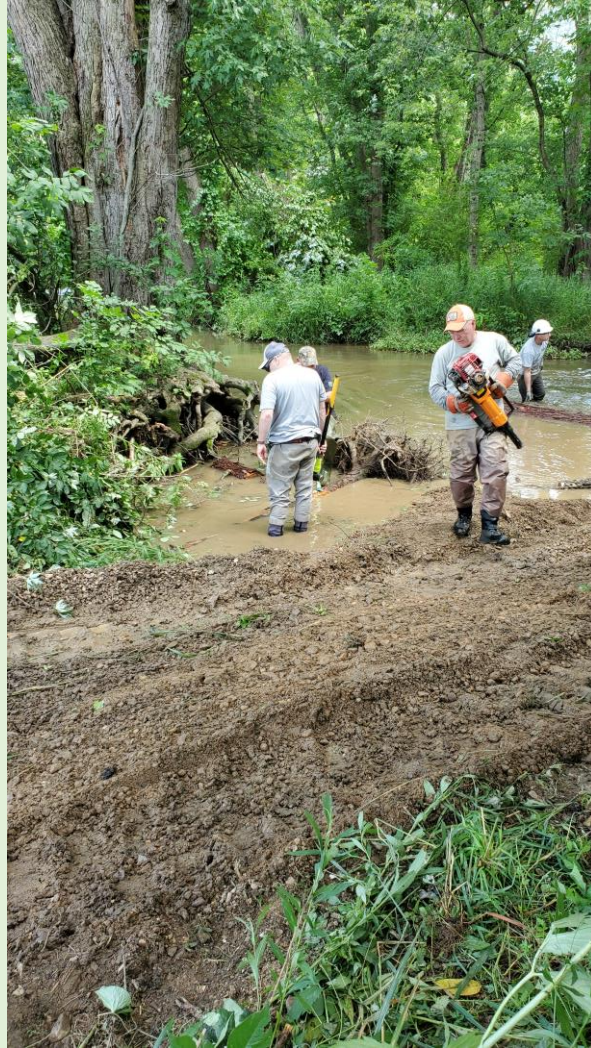
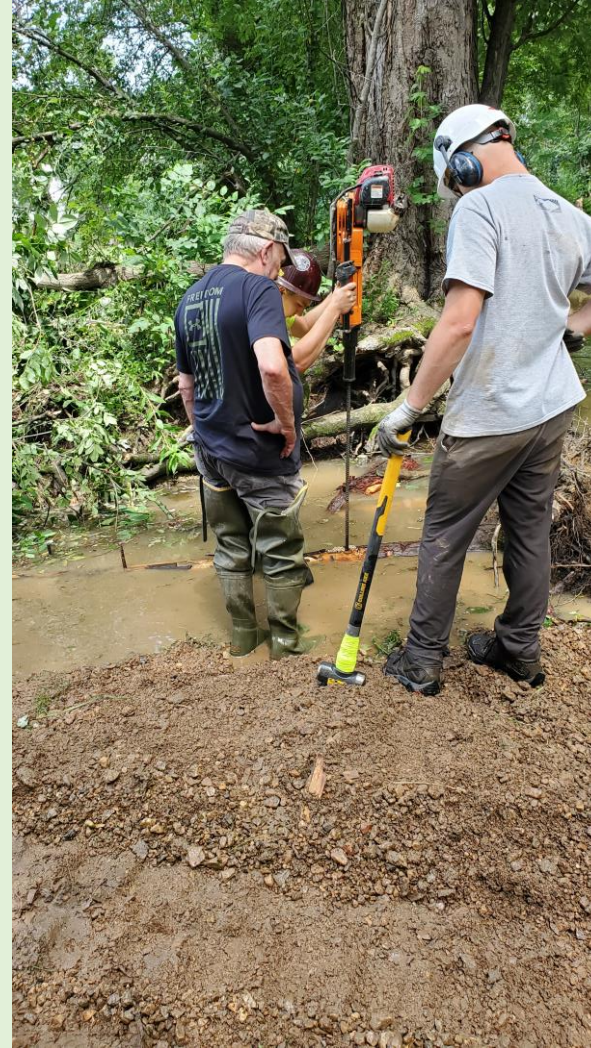
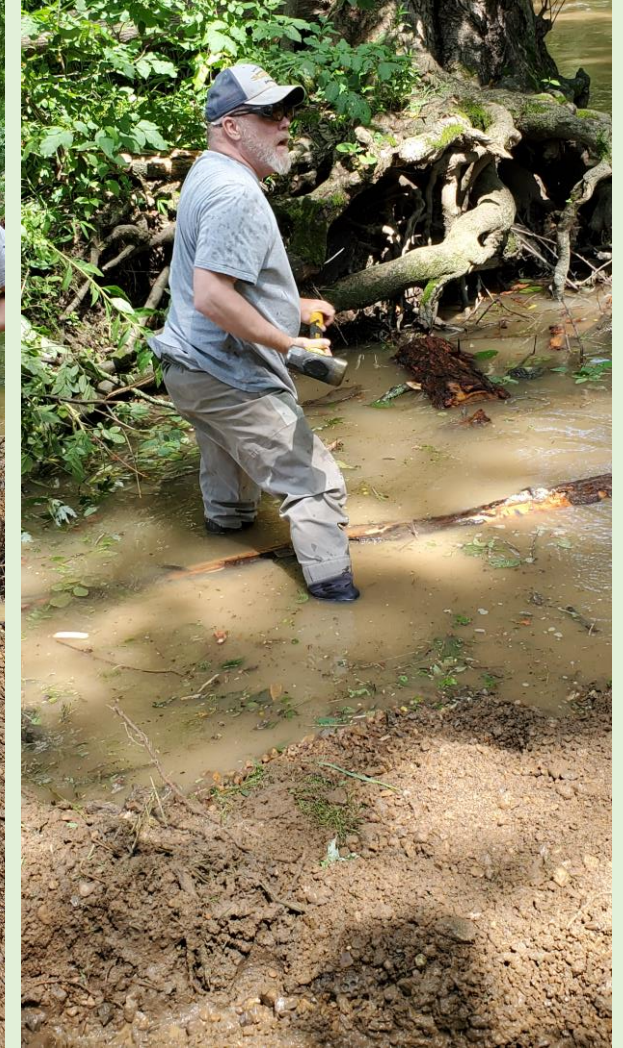
## Phase Three – July 21, 2023

Note: This work corresponds to devices near “C” on the plan view aerial photo of the project area.

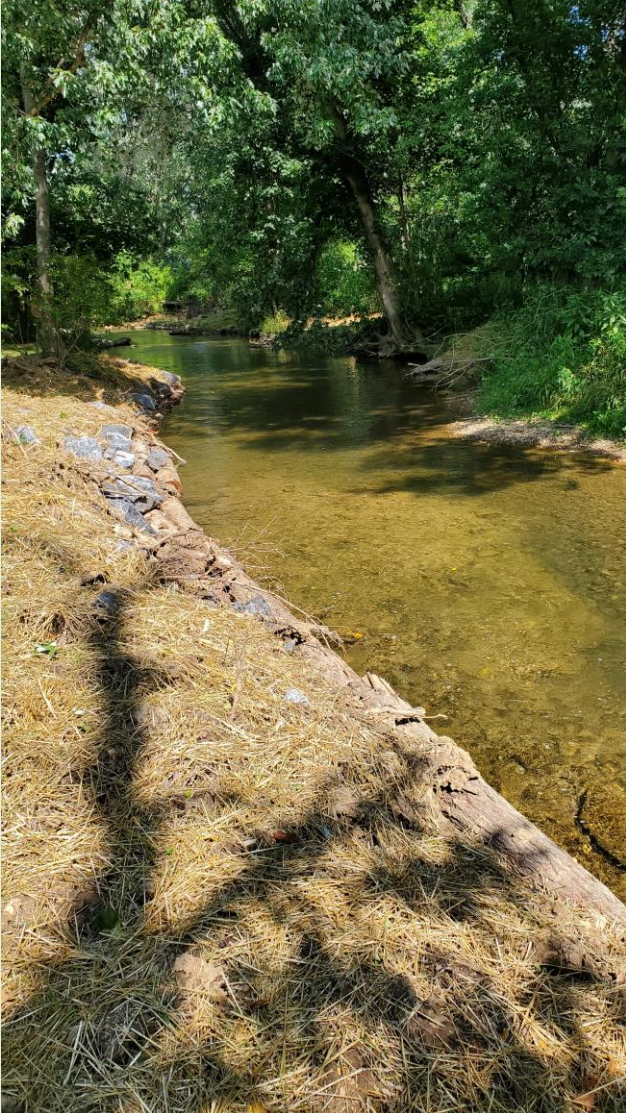
18 days later, we stopped to see how well the grass was coming along after a long dry spell. Not so good.

The long deflector at "C".

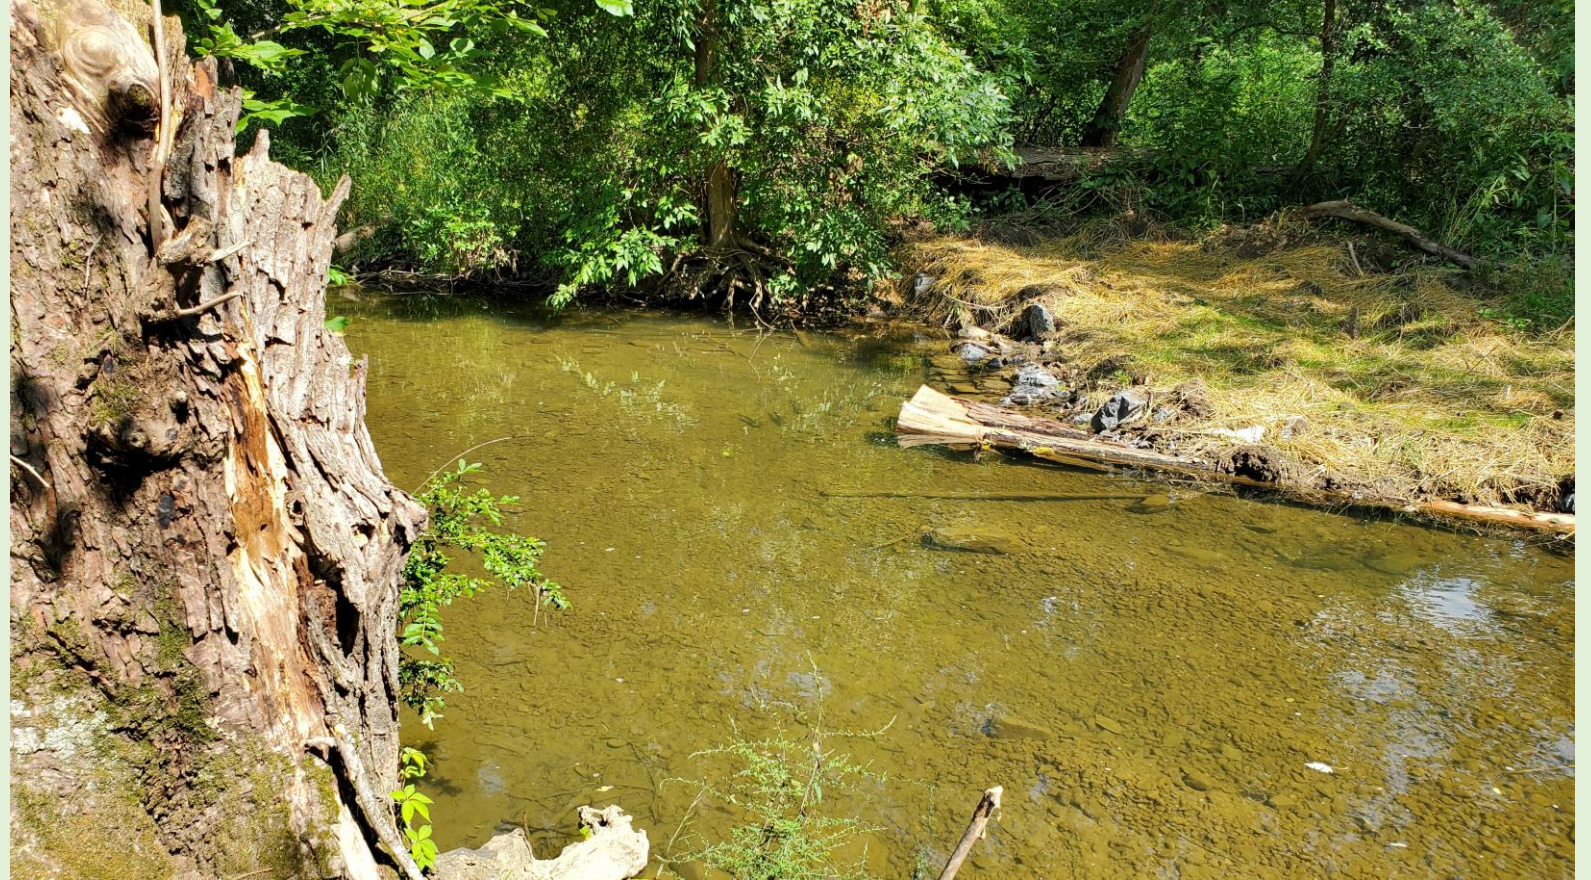
The mod mud-sill at "D".
